NASA - CR - 72353

JOINING REFRACTORY/AUSTENITIC BIMETAL TUBING

Supplemental Report

National Aeronautics and Space Administration

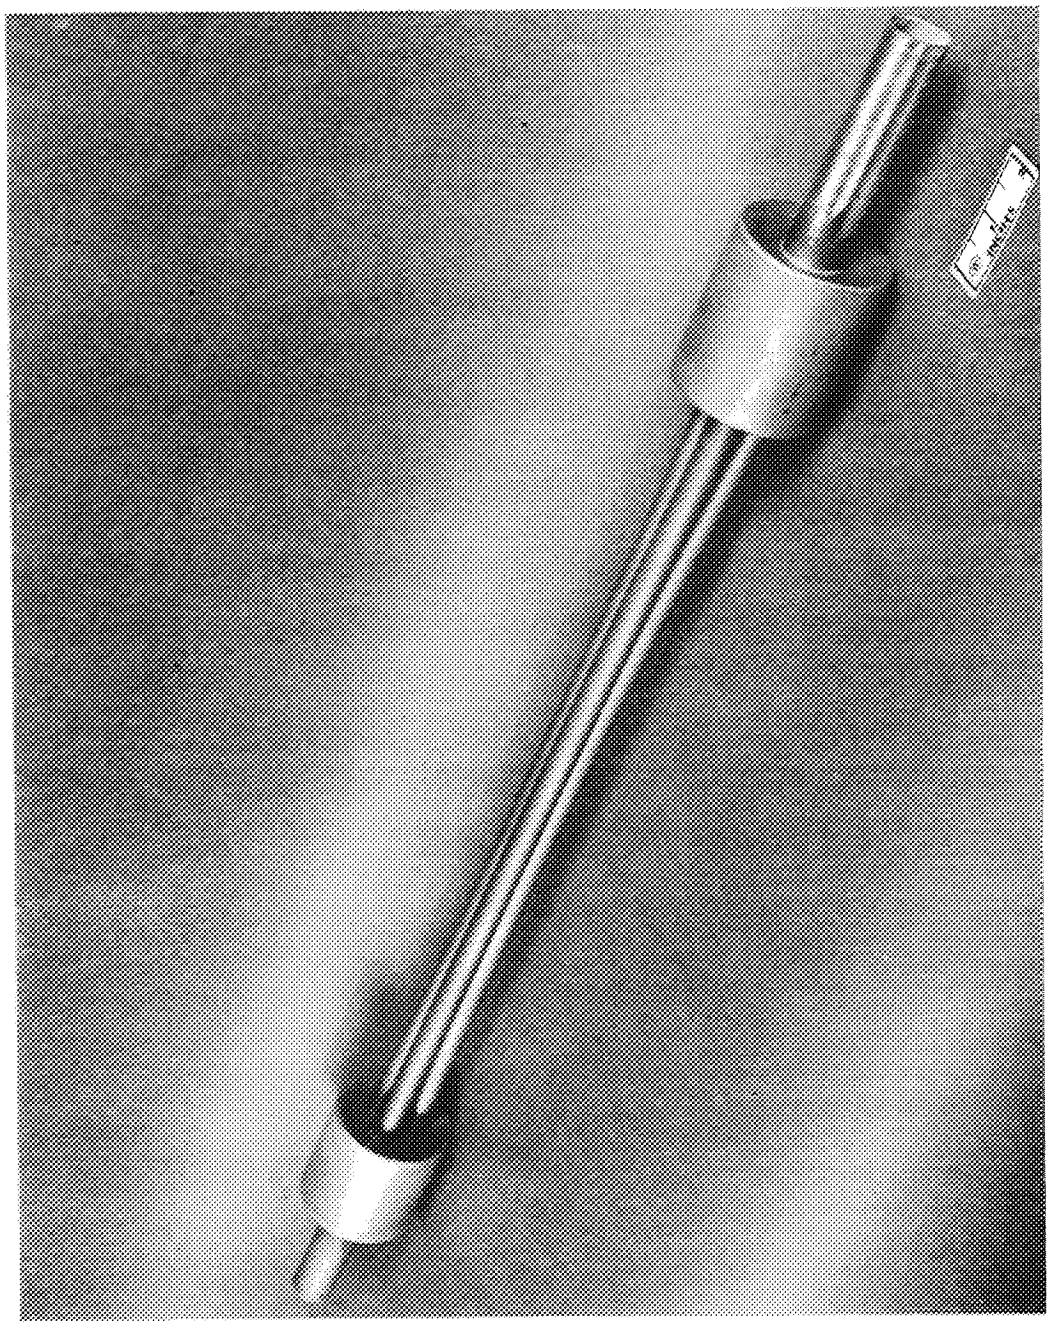
FIGURE 1 - Bimetal Tubing Heat Exchanger

This tubing was coated in the form of a small sized heat exchanger. Figure 1 shows the completed heat exchanger comprised of three, 20 inch long bimetal tubes. Some distortion occurred during the coating process due to a pressure build-up in the protective can. The coating processing sequence was as follows:

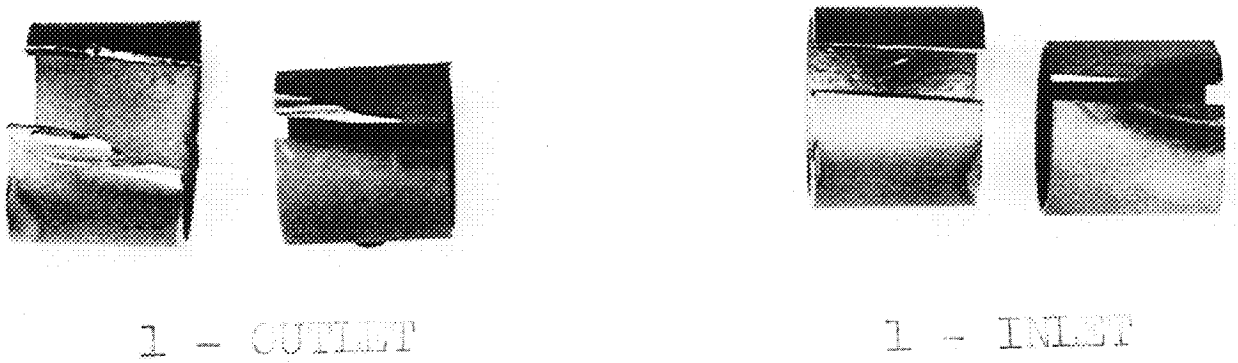
FIGURE 2 - Chemically Vapor Deposited Tubing

The heat exchanger was sectioned and the initial evaluation indicated very poor bonding and very high hardness in the vapor deposited tantalum. Figure 2 indicates the lack of bonding shown by longitudinally sectioning the tubing. Chemical analyses were made of the tantalum layer which indicated very high carbon content of nearly 0.5%. The hardness measurements and chemical analyses are shown in Table 1.

Because of the poor quality of the vapor deposited tubing, further evaluation of this item was discontinued.

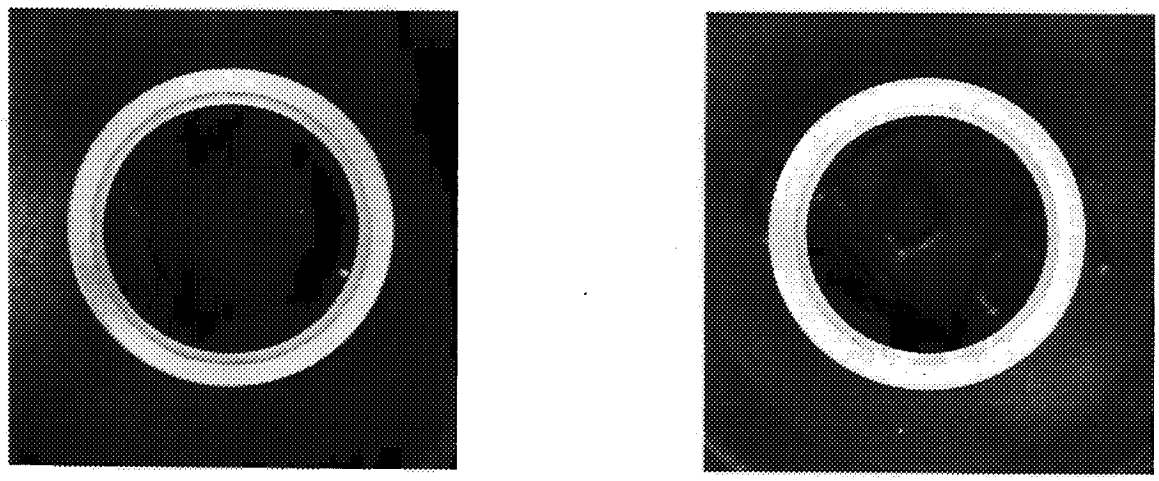
FIGURE 7 - Transverse Tube Sections

Cross sections of the co-extruded and drawn and explosively bonded and drawn tubing are shown in Figure 7. The explosively bonded and drawn tubing occasionally shows severe variations in refractory liner thickness which are not reflected in the variations shown in Table 2. The explosively bonded to size tubing, not shown in section view, had the least variation in refractory clad thickness.

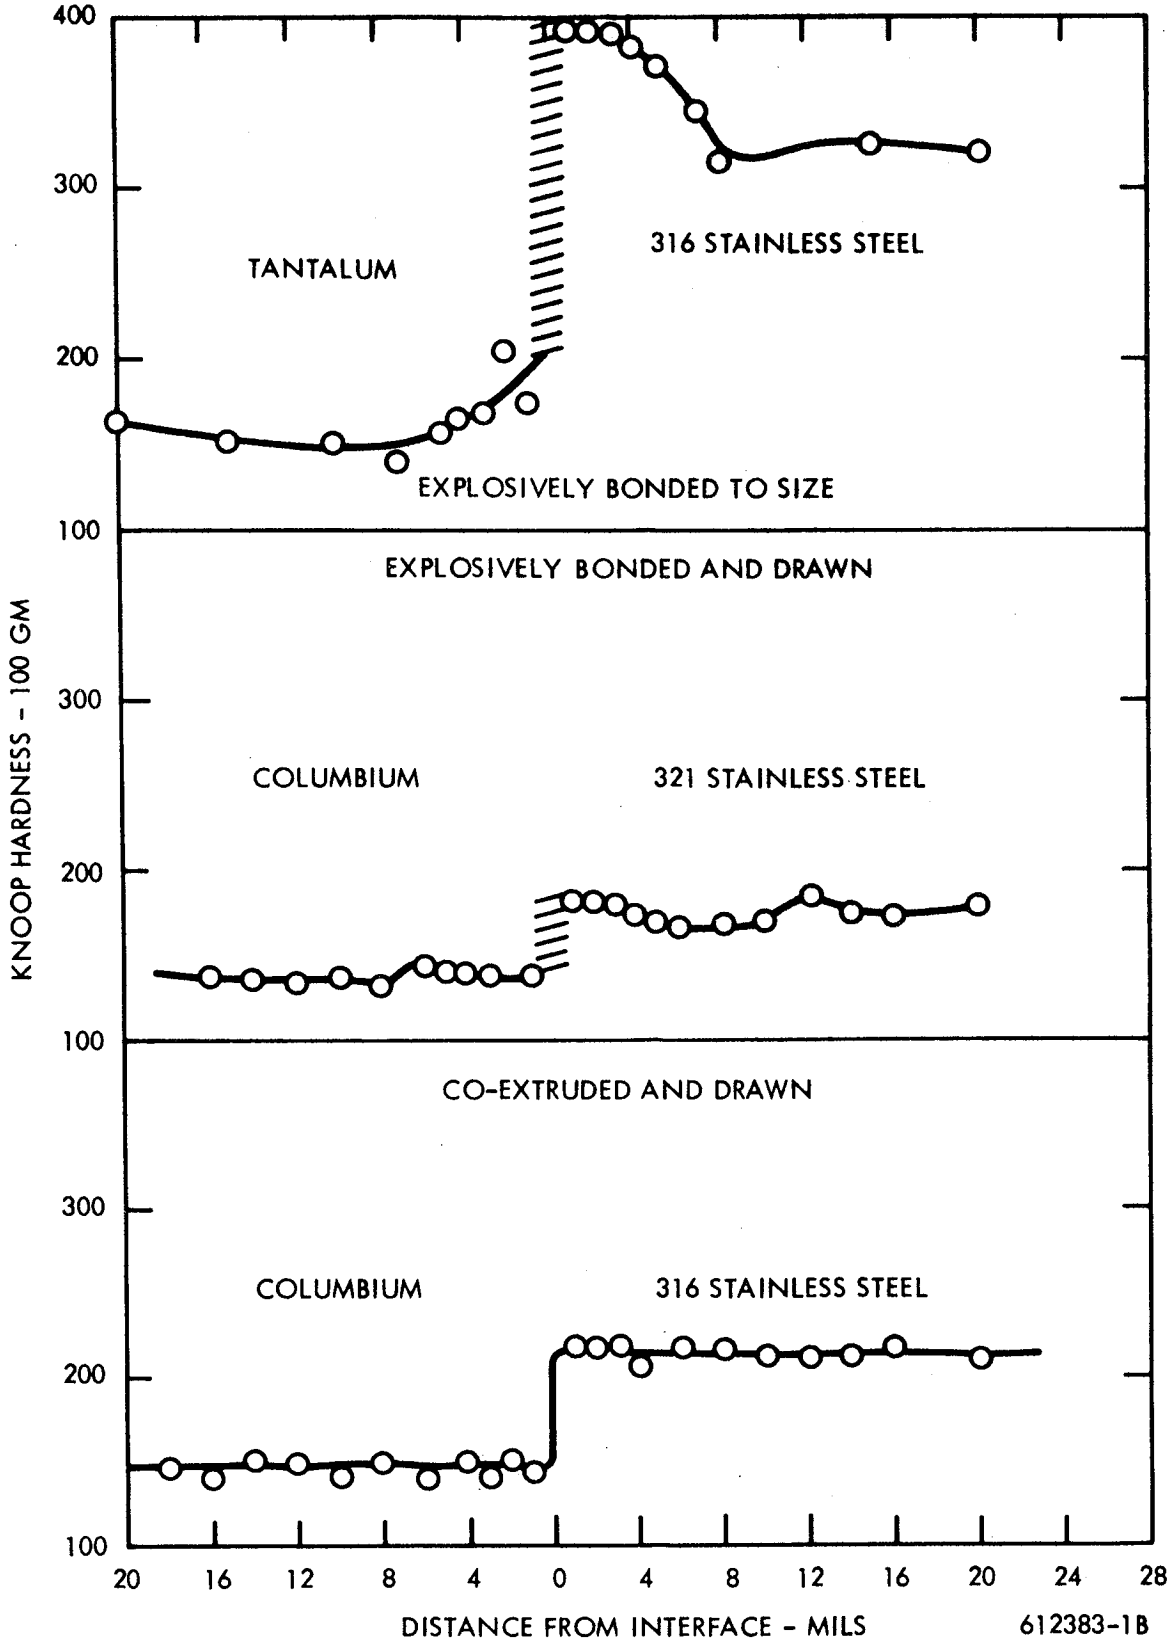
FIGURE 8 - Bimetal Interface Hardness Traverses

The results of bimetal interface hardness traverses are shown in Figure 8. The explosively bonded to size tubing is significantly different than the other tubing in that the stainless steel is much harder through the entire cross section and the hardness of both the tantalum liner and the stainless steel builds up to a maximum at the bimetal interface. This behavior is typical of explosively bonded material and has been previously observed. The stainless steel is severely work hardened by the explosive bonding operation. Several annealing steps were used in producing the explosively bonded and drawn tubing, thus lowering the hardness to the values shown. Since the co-extruded product is extruded at ~1800°F and the tubing is also annealed between the drawing operations, a moderate hardness in the stainless steel results.

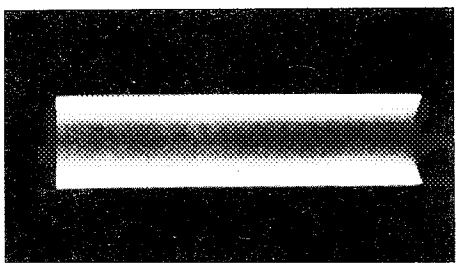
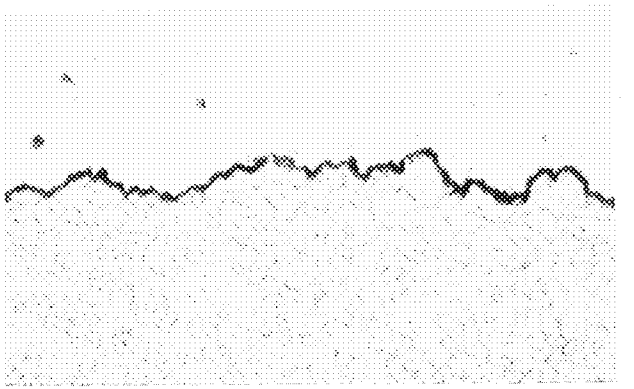
FIGURE 9 - Co-extruded and Drawn Bimetal Tubing

The co-extruded and drawn tubing displayed excellent bimetal bonding as inspected non-destructively by through transmission ultrasonic testing and destructively by metallographic section. Three feet of tubing were ultrasonically inspected and 12 metallographic sections were obtained from the original 20 foot length of bimetal tubing.

Figure 9a shows the interface configuration. The stainless steel layer was chemically removed with concentrated HCl and H_2O_2 permitting visual inspection. Figure 9b shows the information obtained by radiography. The longitudinal shading fluctuations are produced by the striations shown in Figure 9a.. Figure 9 c shows the interface line obtained from this manufacturing process. Figure 9d shows the interface at 500X.

(a) Co-extruded and Drawn Bimetal Tubing Interface with SS Layer Chemically Removed to Reveal Interface

(b) Radiograph of Co-extruded and Drawn Tubing (Print - Light areas are thicker) Longitudinal Striations shown in (a) are Shown

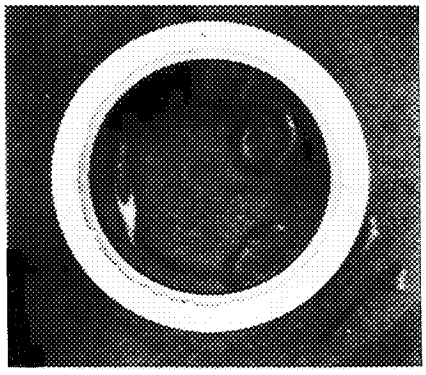
Three feet of this tubing was ultrasonically inspected and a distinct longitudinal unbond area was found. Metallographic sectioning confirmed the existence of a crevice, and Figure 10a is a transverse section showing its transverse length and width. Other sectioning showed that the axial or transverse length of the crack was equal to that shown by the ultrasonic traces. Additional metallographic sectioning was performed to investigate the large fluctuations in layer thickness that were occasionally found. Figure 10b is a typical transverse section. Figure 10c is an example of a well bonded interface.

(b) Transverse Section Showing Typical Interface Found in Explosively Bonded and Drawn Tubing

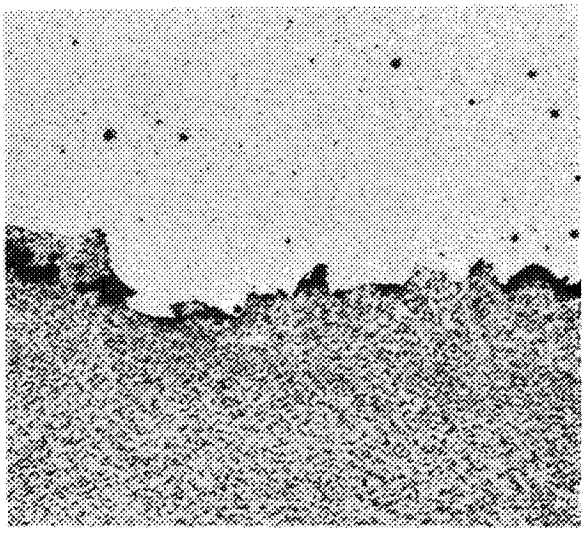
Figures 11a and 11b show the rough interface where thickness variations and voids occur at the interface. These voids were not identified by other non-destructive inspection techniques.

(a) Transverse Section Showing Rough Interface Found Quite Frequently in Explosively Bonded & Drawn Bimetal Tubing.

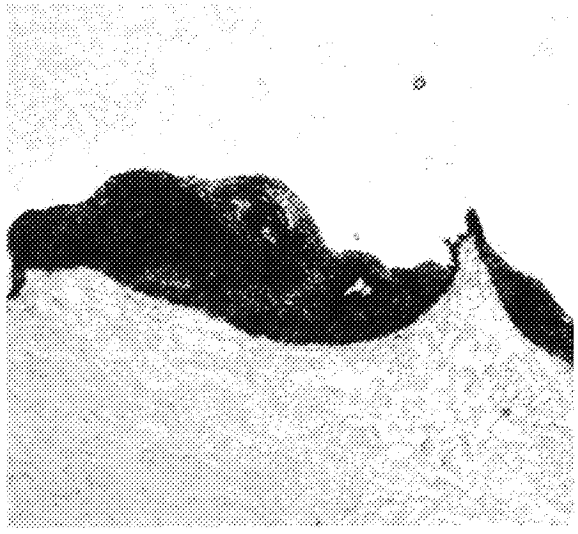
(b) Small Interface Void Found by Metallographic Sectioning

It is important to note that the small voids shown in Figure 11b were not identified by ultrasonic testing. The defect shown in Figure 11b is approximately 5 mils long and about 1 mil wide. The ultrasonic crystal used for inspection is about 1/8 inch in diameter, much larger than the defect. The signal produced is an average of the interface that the crystal covers and defects smaller than 1/32 inch in diameter cannot disrupt enough of the overall signal to indicate unbonding. This type of defect could probably be identified by ultrasonic techniques involving a smaller diameter crystal and a correspondingly slower inspection speed. The smaller signal diameter may be appreciably disturbed by the rough bimetal interface however, and thus produce spurious signals or a "noisy" background. The development of an ultrasonic inspection technique for small defects would involve considerable time and expense and was beyond the scope of this study.

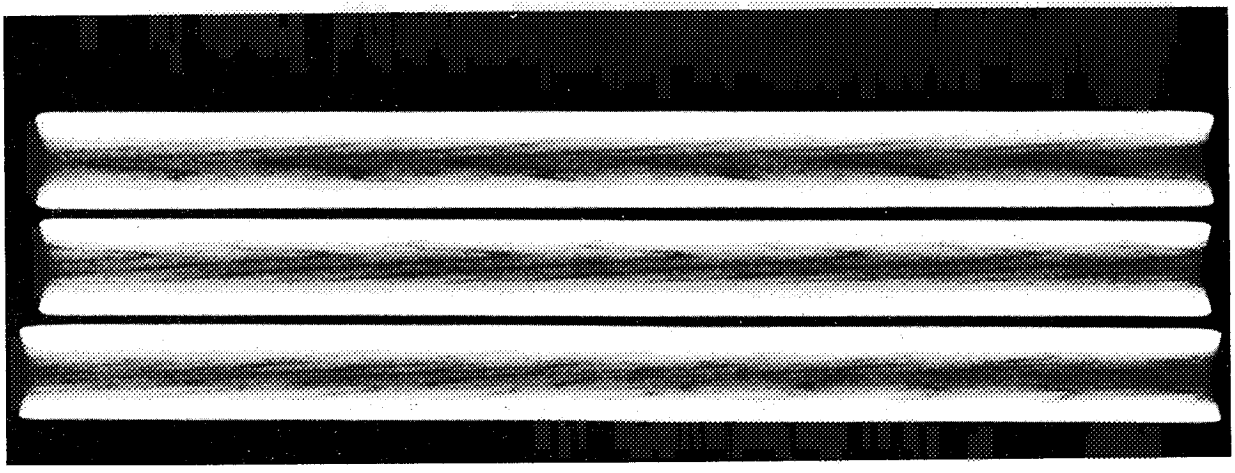
Radiography results are shown in Figure 11c which indicate columbium layer thickness fluctuations but in an unusual pattern.

(c) Radiograph of Explosively Bonded and Drawn Tubing (Print-Light Areas are Thicker) Shading Fluctuations Indicate Probable Interface Irregularity.

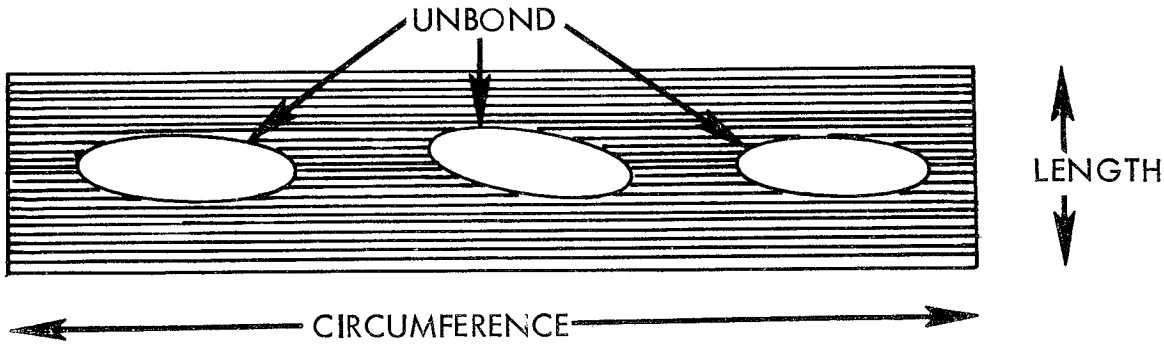
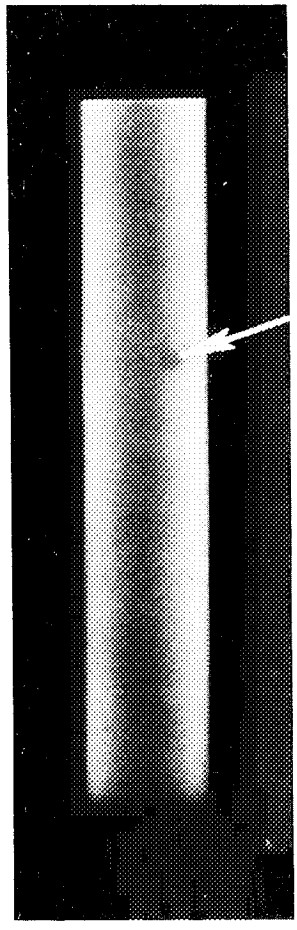
FIGURE 13 - Ultrasonic Trace and Radiograph of Unbonded "Dimples"

Bond Quality — The 2 feet section of tubing received was ultrasonically inspected. The tubing was well bonded except at the dimples required to stand off the Ta tube. The three dimples observed were equally spaced at 10 inch intervals along the length. At the dimple contact area, no separation is possible and defective bonding is produced.

The unbond area is described in Figure 13 which includes an ultrasonic trace and a radiograph print of series of "dimples". The unbond areas appear as a slightly thinner region on the radiograph. Figure 14c and d shows metallographic sections of a "dimple" unbond. Adequate bimetal bonding is maintained in the area adjacent to the dimples as shown in Figure 14b The bimetal interface is very smooth in explosively bonded to size tubing as is observed in Figure 15. The smooth interface is also shown in Figure 16 which shows the outer surface of the tantalum liner with the stainless steel chemically removed.

Unbond indications on ultrasonic trace. "Standoff" Dimples for explosive bonding

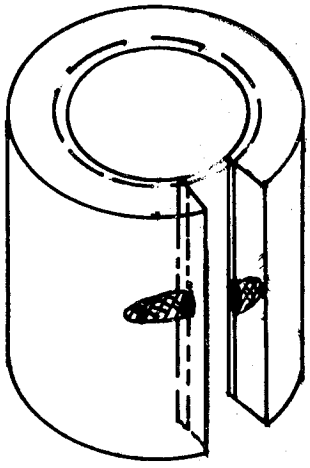
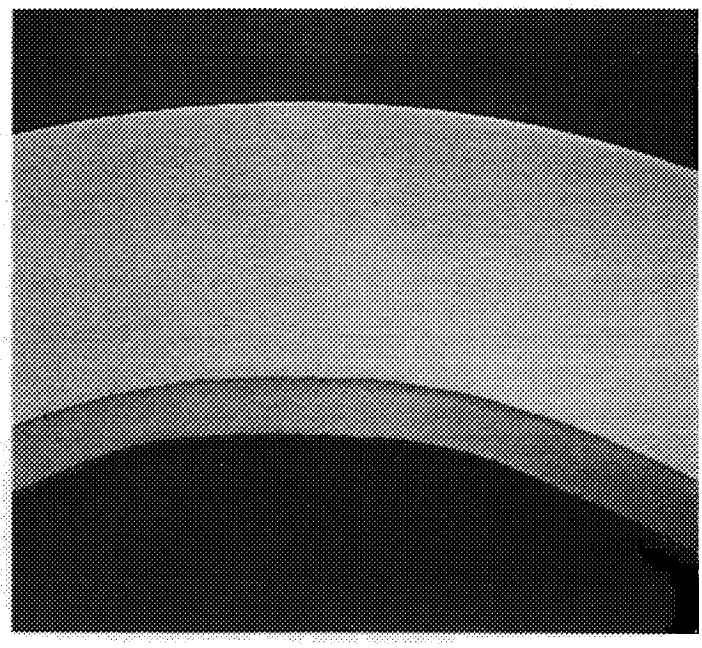
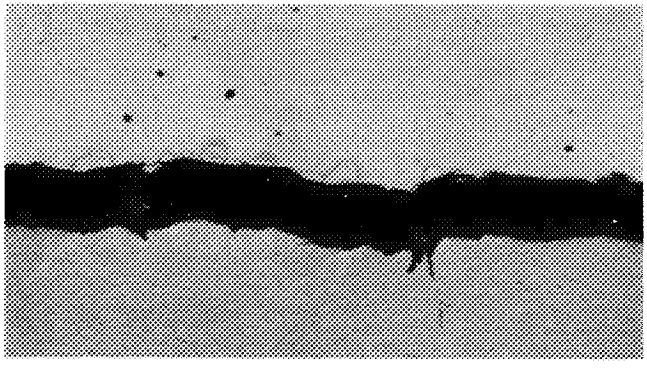
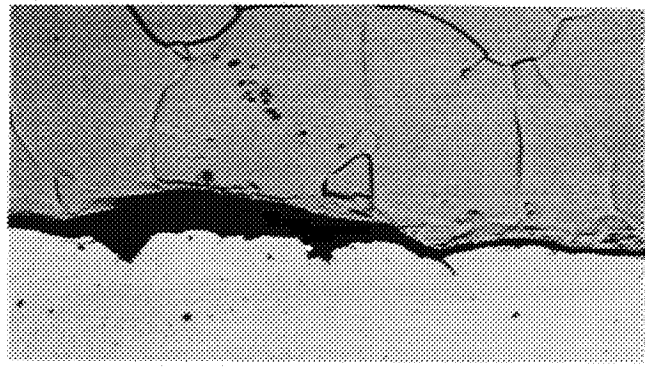
FIGURE 14 - Metallographic Sections of Unbond Dimples

(a) Schematic of unbonding caused by dimpling in exploded to size tubing

(b) Transverse section taken slightly above unbond region

(c) Unbond at center of dimple width 2.5 mils
Transverse Section

(d) Unbond found at longitudinal extremity of dimple. Length 5 mils width 1 mil
Transverse Section

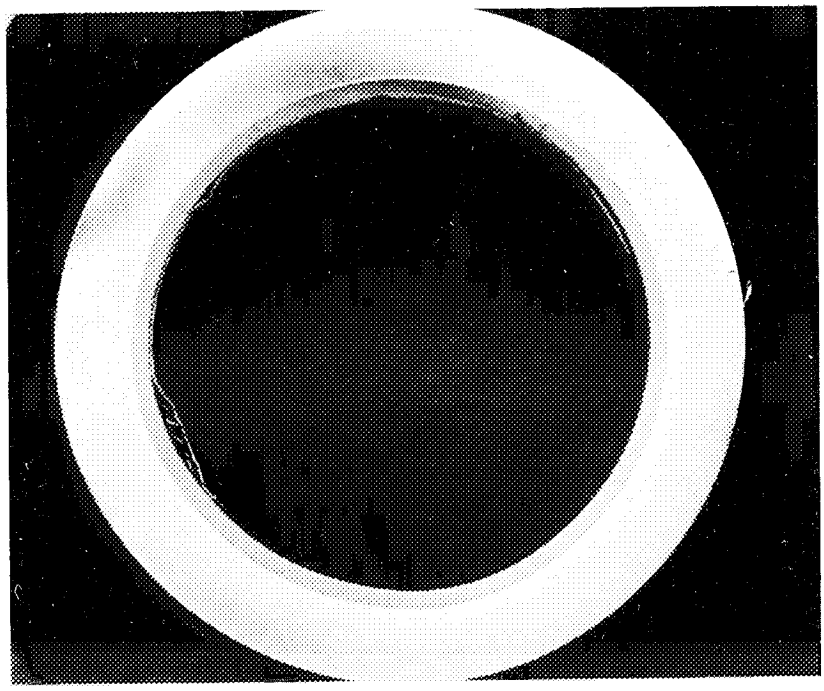
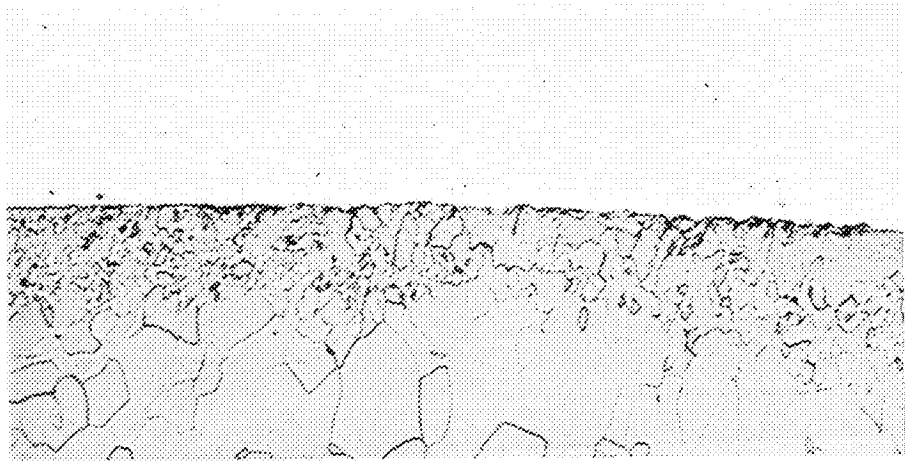
(a) Transverse section of exploded to size bimetal tubing from dimple showing uniform layer thickness and well bonded interface

(b) Transverse section showing acceptable metallurgical bonding
